Long-Term Performance Degradation of Polyurethane Foam Fillers in Military Aircraft Fuel Tanks

The manuscript was received on 12 March 2025 and was accepted
after revision for publication as a case study on 10 December 2025.

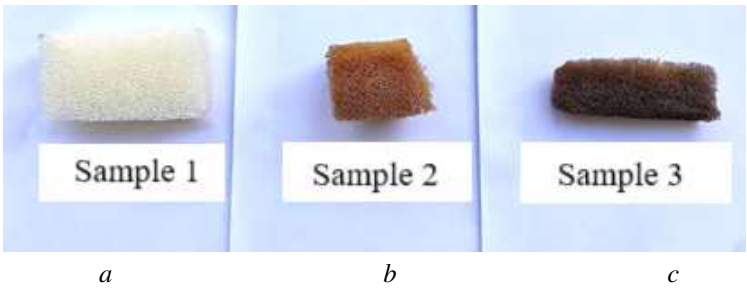
Fig. 1 General view of the tested samples:

a – sample 1 was not installed in the fuel tanks;

b – sample 2 was installed in the fuel tanks and exposed to aviation fuel for 5 years;

c – sample 3 was installed in the fuel tanks and exposed to aviation fuel for 10 years

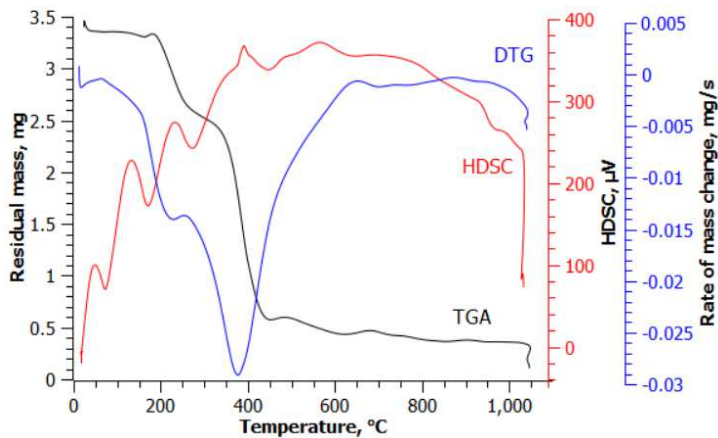
A detailed analysis of the thermogram (Fig. 2) of a sample of a new polymeric filler that was not installed in fuel tanks (Sample 1) shows that the change in the thermophysical properties of the material begins to be observed at a temperature of 227 °C (HDSC curve). A significant and intensive decrease in the weight of the sample of 75 % was observed in the temperature range of 212–430 °C (TGA and DTG curves). With a further increase in temperature, the sample completely burns; complete burning occurs within the temperature range of 460–928 °C (TGA curve). The study recorded that during the heating of the sample, a heat release of 4.3272 J/kg was observed.

Fig. 2 Thermogram of the PU foam filler sample, which was not installed in fuel tanks

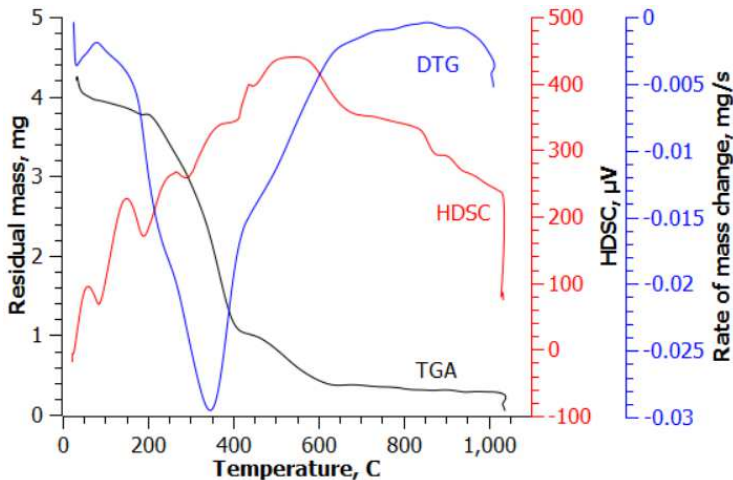
The thermogram (Fig. 3) of the polymeric filler, which was exposed to aviation fuel for 5 years (Sample 2), shows that the change in thermophysical properties began at a temperature of 205 °C (HDSC curve), which is comparatively lower than for the sample of new filler. The sample lost weight within a narrower range of temperatures, 235–355 °C (TGA and DTG curves). The weight was decreased by 17 % within this temperature interval, and the complete burning of the sample was observed in a 355–922 °C interval (TGA curve), significantly wider than for the new polymeric filler. The amount of heat released and recorded in the sample heating was 13.8424 J/kg.

Fig. 3 Thermogram of the PU foam filler sample, which was exposed to aviation fuel for 5 years

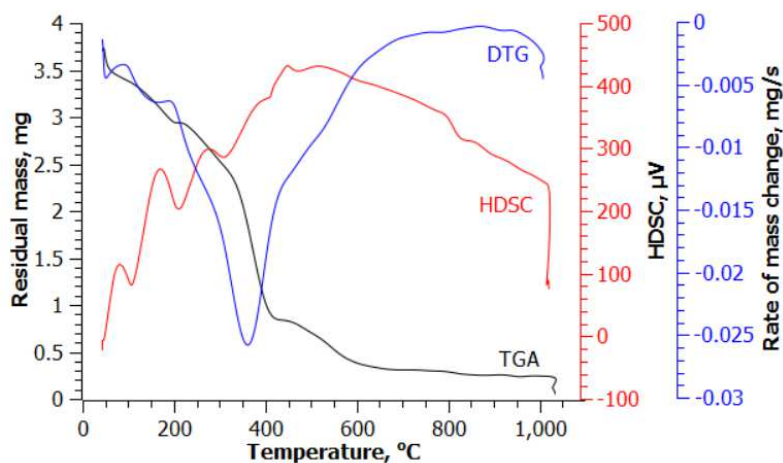
A detailed analysis of the thermogram (Fig. 4) of a sample of the polymeric filler, which was exposed to aviation fuel for 10 years (Sample 3), shows that the change in thermophysical properties began to be observed at a temperature of 201 °C (HDSC curve). Reduction of sample weight was observed in the temperature range of 230–

390 °C (TGA and DTG curves); within this interval, the sample weight was reduced by 19 %. Complete burning of the sample is observed during further heating in a temperature interval of 390–830 °C (TGA curve). The heating process was accompanied by the release of heat in an amount of 13.8424 J/kg, which is quite similar to that of Sample 2.

Fig. 4 Thermogram of the PU foam filler sample, which was exposed to aviation fuel for 10 years

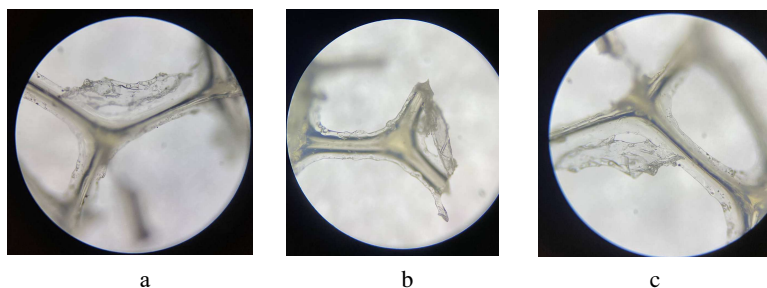
Sample 1 of a new PU foam filler, which was not installed in fuel tanks (Fig. 5), looks like a pure white sample, clearly showing a structure similar to that of a sponge. This structure consists of individual cells of various shapes, including hexagons, and these cells are arranged in multiple rows. The entire structure is a frame that forms the cells. The cell wall is an element of the frame (dark line) with an uneven layer of transparent coating.

Fig. 5 Microphotographs of the PU foam filler sample, which was not installed in fuel tanks, magnification $\times 150$

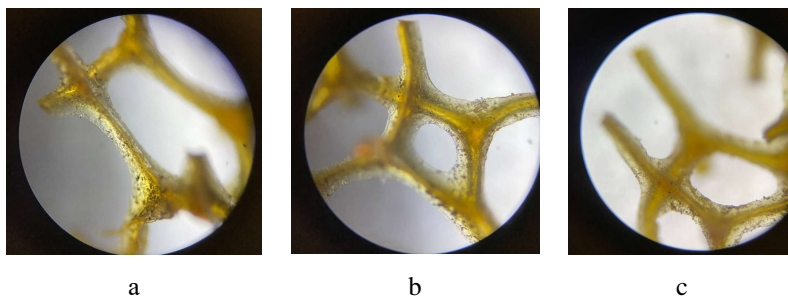
Microphotographs of Sample 2, which was exposed to aviation fuel for 5 years, are shown in Fig. 6. It is seen that the coating has changed its color from white to brown, and the shape and size of the channels have changed. The walls of the cells became yellow, the frame line was not visible, and black dots (particles) appeared, the nature of which is not identified. These could be pores in the wall material or deposits of newly formed particles that may have resulted from the contact with fuel, which is more likely. The number of dark inclusions increases significantly in the film inside the cells. A noticeable reduction in the wall coating material within the cells is observed, along with the emergence of structural irregularities. Additionally, breaks in the cell walls are evident. The ruptures are sudden, as there is no thinning of the walls, typical of gradual destruction. Black inclusions may be foreign microparticles suspended in the fuel and not removed during filtration. They can be deposited on the cell walls due to contact with the fuel. Compared to the others, the lighter inclusions are fragments of the coating with a double frame line, with broken walls and dark dots. A chaotic arrangement of the destroyed walls was found. An increase in the concentration of black particles is observed, especially on the overlay coating inside the cells.

A characteristic feature of all the destroyed walls is a significant decrease in the coating overlaps inside the cells.

Fig. 6 Microphotographs of the PU foam filler sample, which was exposed to aviation fuel for 5 years, magnification $\times 150$

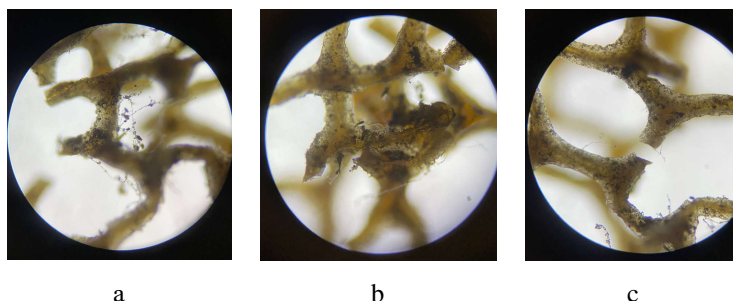
Microphotographs of Sample 3, which was exposed to aviation fuel for 10 years, are shown in Fig. 7. There is a noticeable color change compared to the sample of the new filler and the sample that has been in operation for five years. The investigated sample (Figs 7a and 7b) has a dark gray-brown color, and there are changes in the size and shape of the cells. The microphotographs clearly show the destroyed cell walls. Particles contained freely in the fuel settle on the walls and form entire concentration zones. The overgrowth of the coating material, which partially occupied the space of the cells, has almost disappeared. Distortion of the cell shape was observed. Black particles are deposited on the wall and chaotically located concentration zones are visible. Such zones can appear in shaded areas where the fuel flow rate is lower than in the main flow, and the fuel does not wash away the particles. In one of the cells, threads appeared that crossed the space of the cell and held particles of different sizes (Fig. 7a). The destroyed cells are heavily contaminated with black particles; in the central cell in the figure, almost the entire internal space is filled with various deposits. It is visible how the shape of the cells is distorted due to the aging of the material or external forces. The material's color has changed significantly, making the elements of the wall frame barely visible.

Fig. 7 Microphotographs of the PU foam filler sample, which was exposed to aviation fuel for 10 years, magnification $\times 150$

- to replace PPU-EO-100 units promptly, determine the optimal service life of the polymeric channel filler in the aviation fuel environment, considering the material's aging,
- to modify the thermophysical properties of the tank filler material at the manufacturing stage by adding polyfunctional flame retardants that act mainly on the material itself,
- to modify the structure of the cell elements of the polymeric channel filler for tanks.

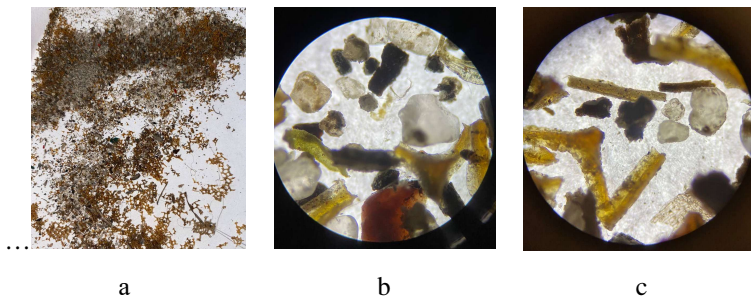
Finally, the pollution on the surface of the filler cells was investigated (Fig. 8). Microphotographs of the surface of the PU foam channels and the channel space between the channels showed that its surface is contaminated with debris of various

origins (chemical analysis of the debris was not performed); most likely, these are blown out corrosion of fuel tanks and other rubber parts inclusions (Fig. 8a). Black inclusions (Figs 8b, c) may be foreign microparticles present in the fuel in suspension and not removed during filtration. They can be deposited on the cell walls when the cell is in contact with the fuel. Lighter particles are likely to be fragments of the coating with a double frame line, with broken walls and dark spots. The coating material does not withstand long-term operation, as it is destroyed by natural aging or applied loads, which compromise the coating structure.

*Fig. 8 Microphotographs of the pollution on the surface of the canals:
a – magnification $\times 20$, b, c – magnification $\times 150$*

These results suggest that the microparticles of contaminants identified during the study may enter the aircraft fuel system and can be carried by the fuel flow into the combustion chamber during operation. Later, these contaminants can be deposited in the fuel injector elements, impairing performance.
