Long-Term Performance Degradation of Polyurethane Foam Fillers in Military Aircraft Fuel Tanks

The manuscript was received on 12 March 2025 and was accepted after revision for publication as a case study on 10 December 2025.

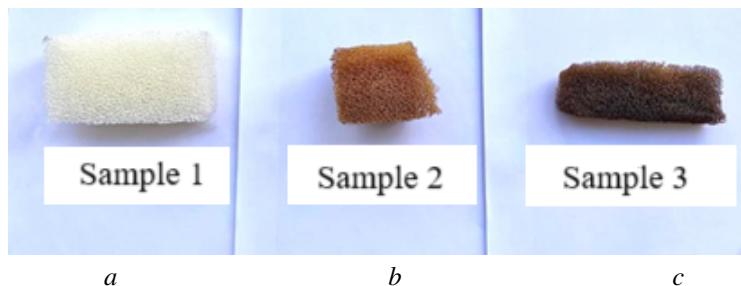
Fig. 1 General view of the tested samples:

a – sample 1 was not installed in the fuel tanks;

b – sample 2 was installed in the fuel tanks and exposed to aviation fuel for 5 years;

c – sample 3 was installed in the fuel tanks and exposed to aviation fuel for 10 years

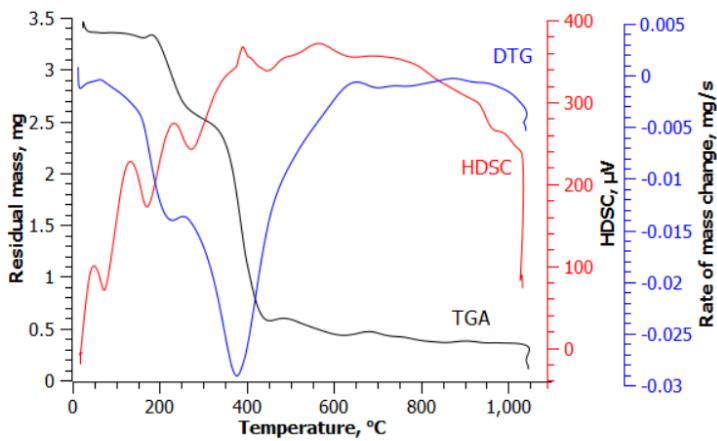
A detailed analysis of the thermogram (Fig. 2) of a sample of a new polymeric filler that was not installed in fuel tanks (Sample 1) shows that the change in the thermophysical properties of the material begins to be observed at a temperature of 227 °C (HDSC curve). A significant and intensive decrease in the weight of the sample of 75 % was observed in the temperature range of 212–430 °C (TGA and DTG curves). With a further increase in temperature, the sample completely burns; complete burning occurs within the temperature range of 460–928 °C (TGA curve). The study recorded that during the heating of the sample, a heat release of 4.3272 J/kg was observed.

Fig. 2 Thermogram of the PU foam filler sample, which was not installed in fuel tanks

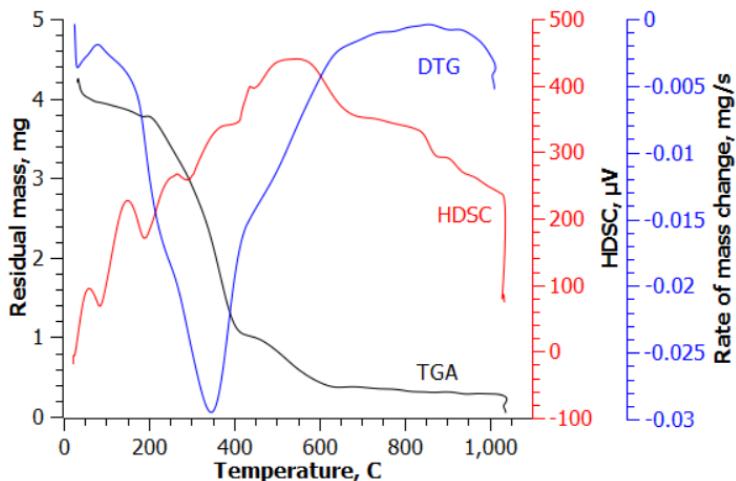
The thermogram (Fig. 3) of the polymeric filler, which was exposed to aviation fuel for 5 years (Sample 2), shows that the change in thermophysical properties began at a temperature of 205 °C (HDSC curve), which is comparatively lower than for the sample of new filler. The sample lost weight within a narrower range of temperatures, 235–355 °C (TGA and DTG curves). The weight was decreased by 17 % within this temperature interval, and the complete burning of the sample was observed in a 355–922 °C interval (TGA curve), significantly wider than for the new polymeric filler. The amount of heat released and recorded in the sample heating was 13.8424 J/kg.

Fig. 3 Thermogram of the PU foam filler sample, which was exposed to aviation fuel for 5 years

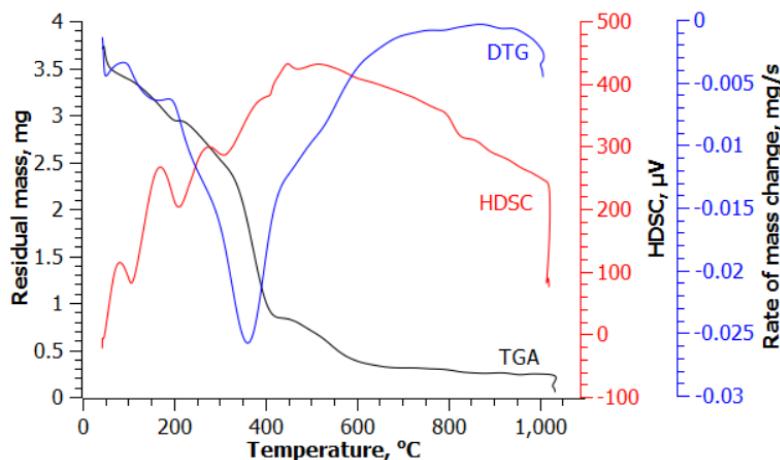
A detailed analysis of the thermogram (Fig. 4) of a sample of the polymeric filler, which was exposed to aviation fuel for 10 years (Sample 3), shows that the change in thermophysical properties began to be observed at a temperature of 201 °C (HDSC curve). Reduction of sample weight was observed in the temperature range of 230–

390 °C (TGA and DTG curves); within this interval, the sample weight was reduced by 19 %. Complete burning of the sample is observed during further heating in a temperature interval of 390–830 °C (TGA curve). The heating process was accompanied by the release of heat in an amount of 13.8424 J/kg, which is quite similar to that of Sample 2.

Fig. 4 Thermogram of the PU foam filler sample, which was exposed to aviation fuel for 10 years

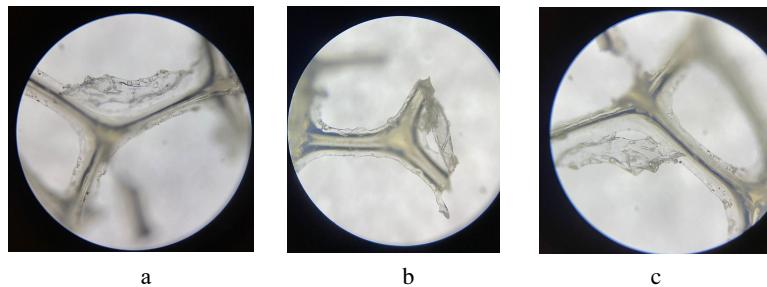
Sample 1 of a new PU foam filler, which was not installed in fuel tanks (Fig. 5), looks like a pure white sample, clearly showing a structure similar to that of a sponge. This structure consists of individual cells of various shapes, including hexagons, and these cells are arranged in multiple rows. The entire structure is a frame that forms the cells. The cell wall is an element of the frame (dark line) with an uneven layer of transparent coating.

Fig. 5 Microphotographs of the PU foam filler sample, which was not installed in fuel tanks, magnification × 150

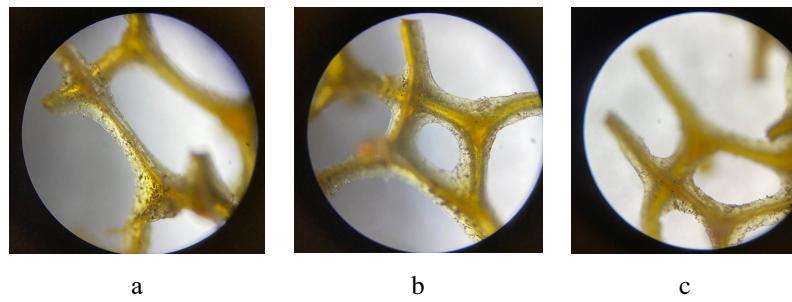
Microphotographs of Sample 2, which was exposed to aviation fuel for 5 years, are shown in Fig. 6. It is seen that the coating has changed its color from white to brown, and the shape and size of the channels have changed. The walls of the cells became yellow, the frame line was not visible, and black dots (particles) appeared, the nature of which is not identified. These could be pores in the wall material or deposits of newly formed particles that may have resulted from the contact with fuel, which is more likely. The number of dark inclusions increases significantly in the film inside the cells. A noticeable reduction in the wall coating material within the cells is observed, along with the emergence of structural irregularities. Additionally, breaks in the cell walls are evident. The ruptures are sudden, as there is no thinning of the walls, typical of gradual destruction. Black inclusions may be foreign microparticles suspended in the fuel and not removed during filtration. They can be deposited on the cell walls due to contact with the fuel. Compared to the others, the lighter inclusions are fragments of the coating with a double frame line, with broken walls and dark dots. A chaotic arrangement of the destroyed walls was found. An increase in the concentration of black particles is observed, especially on the overlay coating inside the cells.

A characteristic feature of all the destroyed walls is a significant decrease in the coating overlaps inside the cells.

Fig. 6 Microphotographs of the PU foam filler sample, which was exposed to aviation fuel for 5 years, magnification $\times 150$

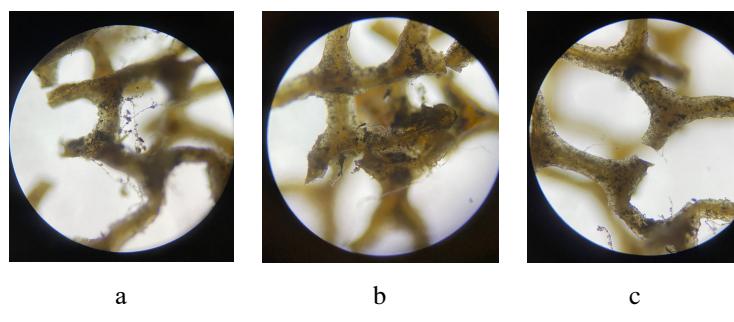
Microphotographs of Sample 3, which was exposed to aviation fuel for 10 years, are shown in Fig. 7. There is a noticeable color change compared to the sample of the new filler and the sample that has been in operation for five years. The investigated sample (Figs 7a and 7b) has a dark gray-brown color, and there are changes in the size and shape of the cells. The microphotographs clearly show the destroyed cell walls. Particles contained freely in the fuel settle on the walls and form entire concentration zones. The overgrowth of the coating material, which partially occupied the space of the cells, has almost disappeared. Distortion of the cell shape was observed. Black particles are deposited on the wall and chaotically located concentration zones are visible. Such zones can appear in shaded areas where the fuel flow rate is lower than in the main flow, and the fuel does not wash away the particles. In one of the cells, threads appeared that crossed the space of the cell and held particles of different sizes (Fig. 7a). The destroyed cells are heavily contaminated with black particles; in the central cell in the figure, almost the entire internal space is filled with various deposits. It is visible how the shape of the cells is distorted due to the aging of the material or external forces. The material's color has changed significantly, making the elements of the wall frame barely visible.

Fig. 7 Microphotographs of the PU foam filler sample, which was exposed to aviation fuel for 10 years, magnification $\times 150$

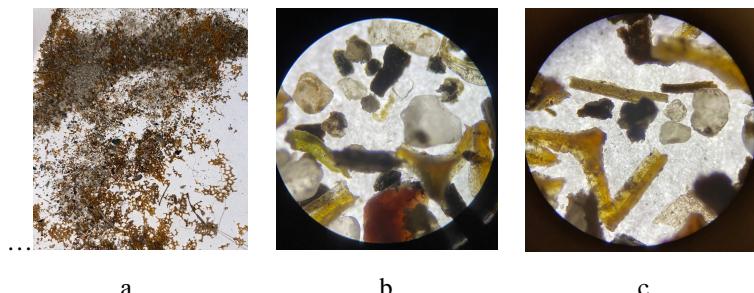
Finally, the pollution on the surface of the filler cells was investigated (Fig. 8). Microphotographs of the surface of the PU foam channels and the channel space between the channels showed that its surface is contaminated with debris of various

origins (chemical analysis of the debris was not performed); most likely, these are blown out corrosion of fuel tanks and other rubber parts inclusions (Fig. 8a). Black inclusions (Figs 8b, c) may be foreign microparticles present in the fuel in suspension and not removed during filtration. They can be deposited on the cell walls when the cell is in contact with the fuel. Lighter particles are likely to be fragments of the coating with a double frame line, with broken walls and dark spots. The coating material does not withstand long-term operation, as it is destroyed by natural aging or applied loads, which compromise the coating structure.

*Fig. 8 Microphotographs of the pollution on the surface of the canals:
a – magnification $\times 20$, b, c – magnification $\times 150$*

These results suggest that the microparticles of contaminants identified during the study may enter the aircraft fuel system and can be carried by the fuel flow into the combustion chamber during operation. Later, these contaminants can be deposited in the fuel injector elements, impairing performance.
