# Selected Problems in Friction Stir Welding of Titanium and Aluminum Armor Grade Alloys

*In this paper, authors reported selected problems in friction stir welding (FSW) of 5 mm-thick AA7075-T651 and 3 mm-thick Ti6Al4V. The investigation involved macro and micro-structure analysis and mechanical testing. The welded joints of Ti6Al4V were characterized by the presence of backing plate steel fragments and tungsten particles in the bottom part of the stir zone (SZ) and thermo-mechanically affected zone (TMAZ), which resulted in a relatively low value of joint efficiency (60 %). The investigation on AA7075-T651 was concerned with high-speed FSW (HSFSW) using the MX Triflute tool. In all cases, defective welded joints have been obtained (incomplete root penetration, voids in the SZ) with the best result of joint efficiency of about 59 %.*

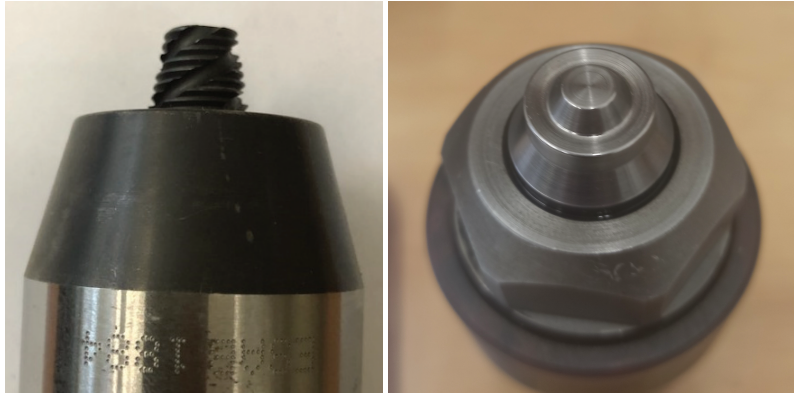
Fig. 1 Welding tools: MX Triflute for joining aluminum (left) and W-La tool for joining titanium (right)

The materials have been cut into pieces with dimensions of 80×500 mm with their edges precisely machined by milling. The welding process has been conducted on ESAB FSW Legio 4UT. In terms of Ti6Al4V, the tool was made of tungsten lanthanum alloy with a taper cylindrical pin. The applied process parameters were 300 rev/min tool rotation speed and 75 mm/min tool traverse velocity. The pin length was 2.9 mm and its depth during the process was -2.9 mm. HSFSW attempts for 5 mm-thick AA7075-T651 using the MX Triflute tool have been conducted in the range parameters of 1000 rev/min, 1250 rev/min, and 1500 rev/min tool rotation speed and 0.5 m/min, 0.75 m/min, and 1 m/min tool traverse velocity. The photos of used welding tools are presented in Fig. 1.

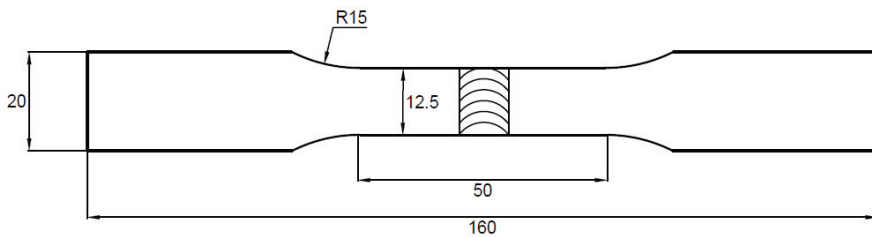
Fig. 2 Scheme of the tensile sample

The investigation involved macrostructural and SEM observations and mechanical testing. The microhardness testing has been performed on Struers DuraScan 70 microhardness tester using 0.98 N load. The microhardness distribution on the joint cross-sections has been established at the distances 0.6, 1.5, and 2.4 mm from the weld face. The tensile test has been conducted in accordance with the ASTM E8/E8M standard on Instron 8802 MTL. The geometry of used tensile sample is presented in Fig. 2.

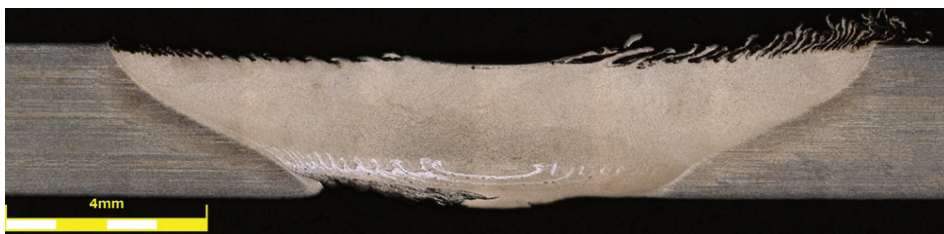
Fig. 3 Macrostructural image of Ti6Al4V FSW joint

The observations of the Ti6Al4V FSW joint revealed the presence of impurities in the bottom part of the stir zone (Fig. 3). Despite this imperfection, no other defects have been reported.

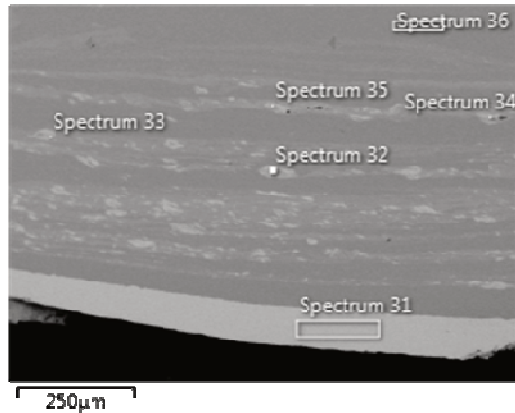
Fig. 4 SEM image of steel fragments in the FSW joint

The fragments of the stirred impurities have been subjected to SEM observation (Fig. 4) and the chemical composition analysis (Tab. 3).

Tab. 3 Chemical composition (weight %) of point and areas marked in Fig. 4

Spectrum	Al	Ti	Fe	W
31	—	—	100.0 %	—
32	2.9 %	44.9 %	51.0 %	1.2 %
33	2.8 %	44.2 %	53.0 %	—
34	2.8 %	41.4 %	55.8 %	—
35	2.1 %	36.8 %	61.1 %	—
36	6.1 %	93.9 %	—	—

The obtained results show that the material stirred into the nugget zone is the steel backing plate used as an element of welding equipment. Additionally, the presence of tungsten (1.2 wt.%) has been revealed which indicates heavy wear of the used W-La tool during the joining process. The stirred particles have also an impact on the microhardness distribution of the joint cross-section, presented in Fig. 5.

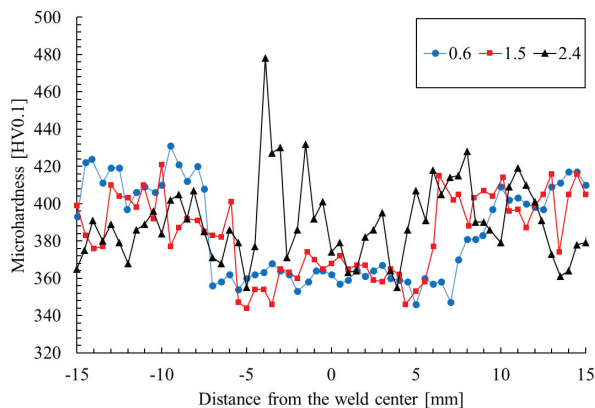
Fig. 5 Microhardness distribution in Ti6Al4V FSW joint at the distances of 0.6, 1.5, and 2.4 mm from the weld face

It can be observed that the width of the stir zone is about 14 mm and it is characterized by a decrease in microhardness, most visibly for 0.6 and 1.5 lines. The FSW process affects the microhardness of Ti6Al4V alloy, reducing its value from about 410 HV0.1 (base material) to 360 HV0.1 (stir zone). Analyzing the curve corresponding to the bottom part of the weld (line “2.4” in Fig. 5), a fluctuation in microhardness value can be observed. The highest reported values of microhardness are the peaks of 2.4 mm line corresponding to 480-440 HV0.1, whose distance from the weld center overlaps with the region rich with stirred steel and tungsten particles. Unintentional enrichment of the stir zone with tungsten alloy particles (having above 500 HV0.1) significantly contributed to the local increase of the microhardness values. The mechanical properties of the joints have been evaluated in the tensile test on six tensile samples taken from the obtained welded joint (Fig. 6).

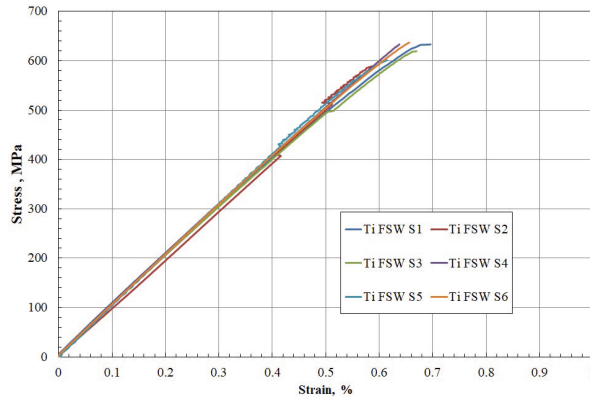
*Fig. 6 Tensile curves of Ti6Al4V FSW joint samples*

The performed mechanical testing of the obtained joint allowed to establish the value of tensile strength equal to  $(622.37 \pm 18.99)$  MPa which corresponds to 60.4 % joint efficiency. The reported elongation at break does not exceed 0.7 % and the failure occurs in the SZ, which proves the low quality of the produced joint. The decohesion of the joint takes place in the region with stirred steel particles, which is possible to observe in the SEM image of fractured samples (Fig. 7).

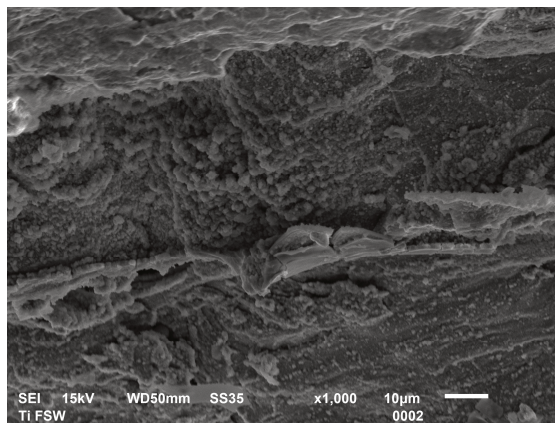
*Fig. 7 SEM image of bottom part of fractured sample*

It is worth mentioning that the tool depth ( $-2.9$  mm) did not allow the complete penetration of the welded workpieces (3 mm), so the tool has no direct contact with the steel backing plate. The potential explanation for the introduction of steel fragments into the stirred region is the in-situ welding of plasticized titanium and the surface layer of the steel backing plate, which is also visible in Fig. 4. Steel fragments underwent further fragmentation in the stir zone, which led to high abrasive wear of W-La tool. The backing plate was made of S355 structural steel. In order to prevent such a phenomenon, the backing plate should be made of a material which does not easily weld itself to the titanium workpieces during the welding (e.g. ceramics).

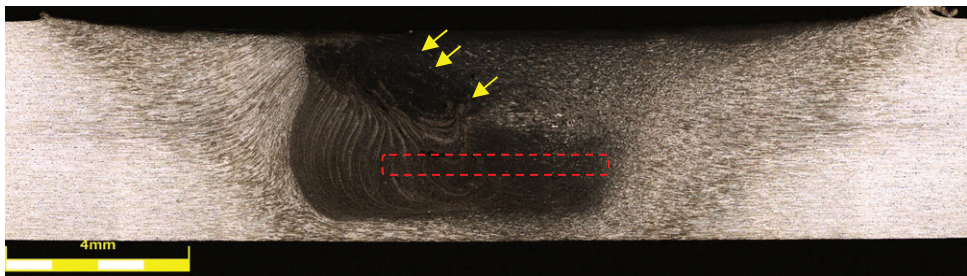
Fig. 8 Macrostructural image of AA7075-T651 HSFSW joint

### 3.2 High-Speed Friction Stir Welding of AA7075-T651

The obtained joint contains two types of defects. First, the incomplete root penetration is directly connected with an insufficient amount of heat in the bottom part of the weld during the process which does not allow for the material to plasticize (red dashed line in Fig. 8). The second defect is voids localized in the upper and central part of the SZ (marked with yellow arrows in Fig. 8), which often form when a difference between temperatures on the joint cross-section is too high, disturbing the plastic flow of the material [3]. Although the participation of defects is not overwhelming, it has serious consequences for the joint mechanical properties (Fig. 9).

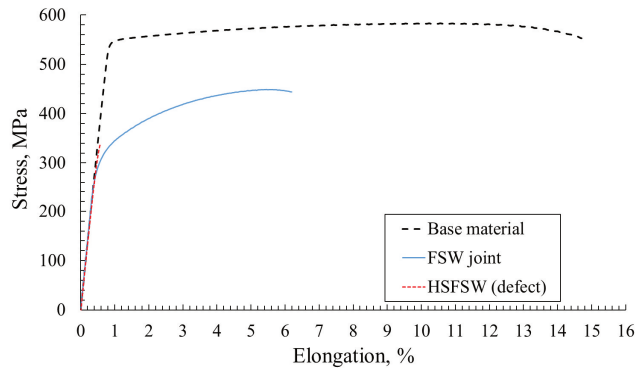
Fig. 9 Comparison of tensile curves for AA7075-T651: base material, FSW joint, defected HSFSW joint

The comparison shows that the tensile strength of the defective HSFSW joint is about 335 MPa, which corresponds to 59 % joint efficiency. It has to be mentioned that a defect-free conventional FSW joint can provide about 76 % [1]. Considering a relatively wide matrix of welding parameters it can be stated that MX Triflute is not the appropriate tool for high-speed FSW of 5 mm-thick elements made of AA7075-T651 alloy. The incomplete root penetration is below 1 mm (Fig. 8), so for thinner sheets, complete penetration should be possible. In most research on HSFSW, the thickness of welded workpieces is 2-3 mm [5, 6]. The defects in the produced joints entail rather poor mechanical properties and the failure occurs in the SZ with its character strongly affected by the discussed imperfections (Fig. 10).

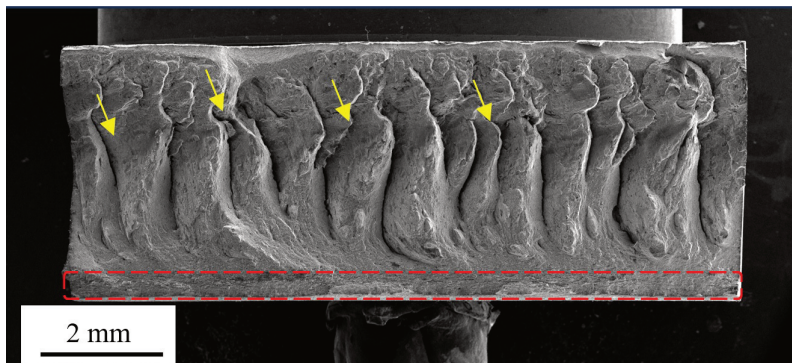
Fig. 10 SEM image of fractured sample

The observations of the fractured surface allow to notice the typical “bands” (marked with yellow arrows) for void-defected FSW joints [3]. The bottom part of the fractured surface (red, dashed line) has the character of fracture corresponding to the base material, which is the effect of incomplete root penetration.
