Capabilities and Limitations of Military Helicopter Wire Strike Protection Systems

O. Zavila*

Department of Air Force, University of Defence, Brno, Czech Republic

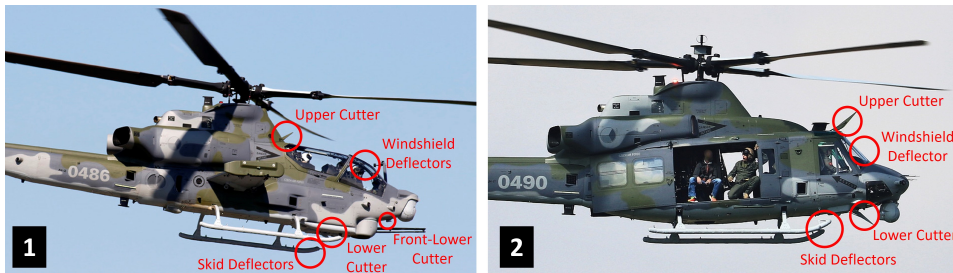
Fig. 1 Elements of the wire strike protection systems on H-1 military helicopters: (1) Bell AH-1Z Viper; (2) Bell UH-1Y Venom [1]

(e.g., the main rotor) in the event of a wire strike. The initial implementation of passive protection systems incorporating wire cutters is observed in the currently introduced H-1 military helicopter family, specifically in the U.S.-manufactured Bell UH-1Y Venom and Bell AH-1Z Viper helicopters (see Fig. 1). These helicopters are equipped with a set of deflectors and wire cutters on both the upper and lower sides of the front fuselage, as indicated by the red circles in Fig. 1.

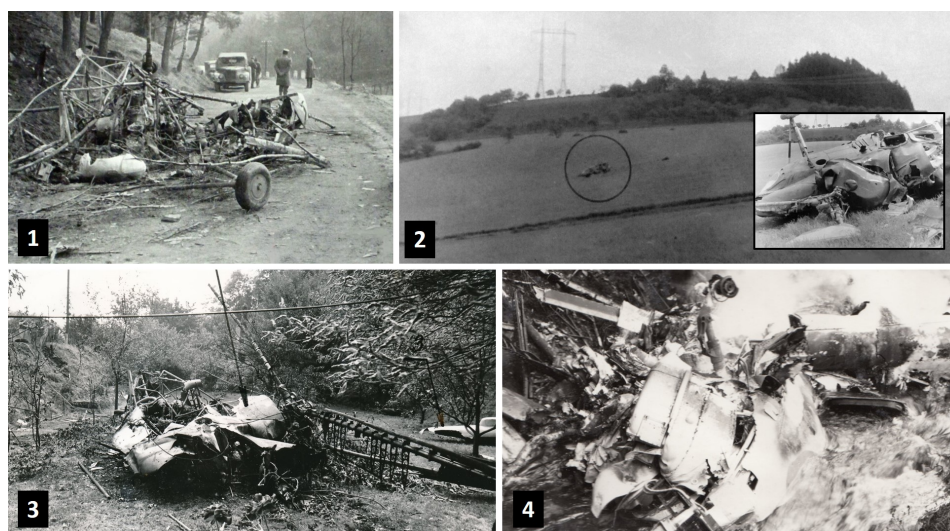
Fig. 2 Aviation disasters of Czechoslovak military helicopters due to wire strikes: (1) 30 March 1967, the Mi-1, pilot 1st Lt P. Joska; (2) 20 May 1969, the Mi-1M, pilot Maj Z. Bouška; (3) 22 June 1973, the Mi-1M, pilot Capt V. Kubeček; (4) 17 May 1983, the Mi-24D, pilot Capt B. Karkošák [3, 4]

Tab. 1 shows that the most prevalent AAs with the most severe consequences were associated with the Mil Mi-1 helicopter (see Fig. 2). There are several reasons for this. The Mil Mi-1 helicopter (maximum takeoff weight: 2 296 kg) was a light general-purpose utility helicopter that performed mostly reconnaissance and liaison tasks. The aircraft was not designed for direct combat, and thus its construction was not particularly resistant to mechanical damage. According to the available archival documents, the helicopters most frequently collided with high-voltage electrical wires. Given the diameter of the cables, their tensile strength is on the order of several tens of kN. Therefore, given the weight, flight speed, and structural rigidity of a light helicopter of the Mil Mi-1 type, it had virtually no chance of breaking the wire without suffering severe or fatal damage. The Mil Mi-4 helicopter (maximum takeoff weight: 7 800 kg) was a medium-heavy helicopter that was also designed for direct combat operations. As a result, the consequences of its collisions with wires were usually less severe compared to those of the Mil Mi-1 helicopter, a similar pattern being observed with the Mil Mi-8 helicopter (maximum takeoff weight: 12 000 kg).

The disaster of the Mil Mi-24D helicopter on 17 May 1983 was primarily attributable to a maneuver executed by the pilot in response to a report from the other crew member via the intercom of wires at a distance of only 60–100 m at a flight speed of 220 km/h at an altitude of 15–30 m above the terrain. From the vantage point of current understanding, the pilot cannot be faulted for his natural reaction. He would have had to undergo specialized training in order to react differently in a given situation of such high stress. However, at that time, such training was evidently not in place. The fundamental issue was that the pilot's intuitive response was to attempt to fly over the wires, rather than leveraging the kinetic energy and rigidity of the helicopter airframe to fly through them with a high probability of survival. Given the armored, very robust construction of the front fuselage and the high kinetic energy generated by the aircraft's weight and airspeed, it is probable that the helicopter would have been able to withstand the impact without sustaining significant damage. Instead, the pilot made an abrupt change in control inputs, rapidly and radically pulling up on the cyclic and collective. The helicopter did not ascend due to excessive longitudinal pitch; rather, it decelerated abruptly, resulting in a shudder caused by the change in airflow around the main rotor blades. The pilot therefore released the collective to the minimum angle of attack of the main rotor blades. This resulted in a collision with an electrical wire, which cut into the lower unarmored part of the fuselage. Concurrently, the main rotor blade wobble led to mechanical damage to the tail boom, as the blade became jammed in the boom, and then the tail section of the helicopter detached. Ultimately, the inevitable crash and fire of the helicopter occurred, with fatal consequences for the crew.

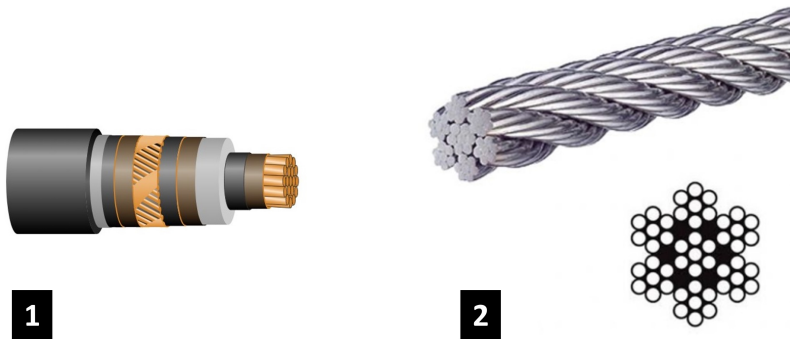
Fig. 3 Example of the difference in design between an electric power cable and a high-strength stranded steel wire rope: (1) electric power cable; (2) high-performance stranded steel wire rope [18]

The commonly used term “wires” encompasses more than just overhead electric power cables or electric power lines (see Fig. 3). It can also refer to high-performance stranded steel wire ropes.

The distinction between them is in their respective tensile strengths at a given diameter, which is a consequence of the dissimilarities in their construction. In general, high-performance stranded steel wire ropes exhibit a higher tensile strength than electric power cables while maintaining the same diameter (i.e., a greater force is required to break them). This is due to the fact that electric power cables are typically composed of multiple layers of diverse materials, with only one layer specifically designed to provide tensile strength. Typically, a central steel core is situated in the center of the cross-section of such a cable, comprising a strand of steel wires that ensures the cable's requisite tensile strength. A conductive sheath surrounds the core, comprising a strand of wires, typically aluminum, to ensure optimal electrical conductivity. Externally, multiple insulating and protective layers are present, offering resilience against external factors, particularly weather conditions. In contrast, high-performance stranded steel wire ropes are constituted exclusively of bundles of steel wires braided in diverse configurations, primarily intended to impart tensile strength.

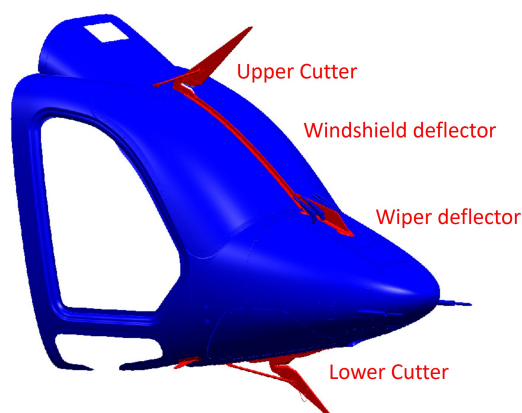
Fig. 4 Example of the configuration of the principal components of the “Cable-Cutting Device” [23]

In accordance with the patent documentation [24] and [25], the “Cable-Cutting Device” is comprised of two groups of components (see Fig. 4):

- deflectors (of landing skids, landing gear wheels, wipers, windscreen, etc.),
- wire cutters (upper, lower, landing gear, etc.).

Deflectors and wire cutters can be of different dimensions, placement and technical designs (see Fig. 5). However, the principle of operation is common to all of them. All types of deflectors serve to direct the wire away from any part of the helicopter structure (especially away from the main rotor head and landing gear) or into one of the wire cutters that are designed to sever the wire.

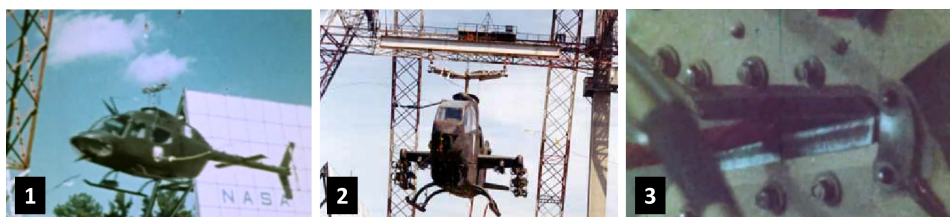
Fig. 6 Large-scale tests on a swing test facility (Ford Eustis, Virginia, U.S.) in 1980 and 1982: (1) the Bell OH-58A Kiowa, (2) the Bell AH-1S Cobra, and (3) close-up view of the cutter cutting the wire [30-32]

All large-scale tests were performed on a swing test facility with actual helicopters at 1:1 scale.

The initial trials were conducted in June 1980 on a Bell OH-58A Kiowa helicopter (see Fig. 6), which was partially stripped of its equipment for this purpose, with a remanent weight of 2 610 lbm (approx. 1 183 kg). A seven-strand steel wire rope with an overall diameter of 3/8 inch (9.525 mm) was used for the tests. It carried a section of 50-pair 0.85-inch (21.59 mm) communications cable comprising 100 copper wires. The carrier rope used had a tensile strength of 11 500 lbf (approx. 5 216 kg). The helicopter's impact speed with the wire was determined to be 40 kt (approx. 74 km/h). The tests demonstrated that no thicker or stronger wires could be cut than the type and diameter tested. However, a potential problem may emerge if multiple wires are placed in a row, as their tensile strengths add up. Conversely, a strike and subsequent successful wire cut should not impair helicopter control, nor cause excessive (dangerous) main rotor blade vibrations [30].

A third series of tests was conducted in December 1982 on the Bell AH-1S Cobra helicopter (see Fig. 6), which was also stripped of equipment for this purpose, with a remanent weight of 6 044 lbm (approx. 2 740 kg). The same type of cable was utilized for the tests as previously with both the Bell OH-58A Kiowa and Bell UH-1H Iroquois helicopters. The helicopter speeds at cable impact were set this time at 40 kt (approx. 74 km/h) and 18 kt (approx. 33 km/h). These tests validated prior experience and reaffirmed the hypothesis that at elevated flight speeds the wire has the potential to cut through the helicopter airframe. Another significant outcome was the realization that, due to the configuration of armament and equipment on the Bell AH-1S Cobra helicopters, comprehensive protection of all parts of the helicopter could not be attained. Therefore, the effectiveness of the helicopter's wire strike protection system is likely to be less than that of the previous types tested (Bell OH-58A Kiowa and Bell UH-1H Iroquois) [32].
