Fire Protection Systems in the Ilyushin Il-28: The Only Jet Bomber in the Czechoslovak and Czech History

O. Zavila*

Department of Fire Protection, VSB – Technical University of Ostrava, Ostrava, Czech Republic

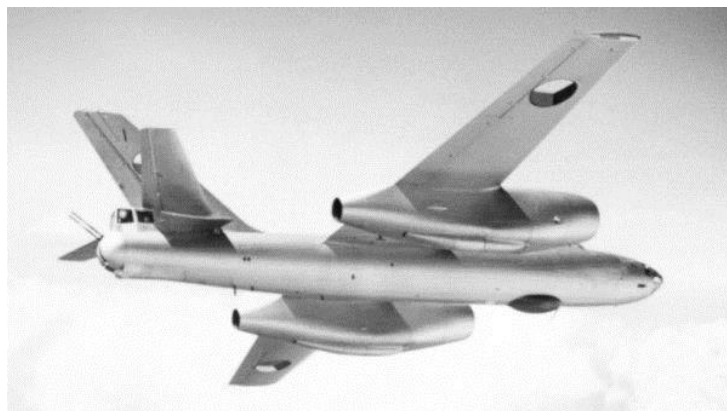
Fig. 1 Vintage photograph of the Il-28 [3]

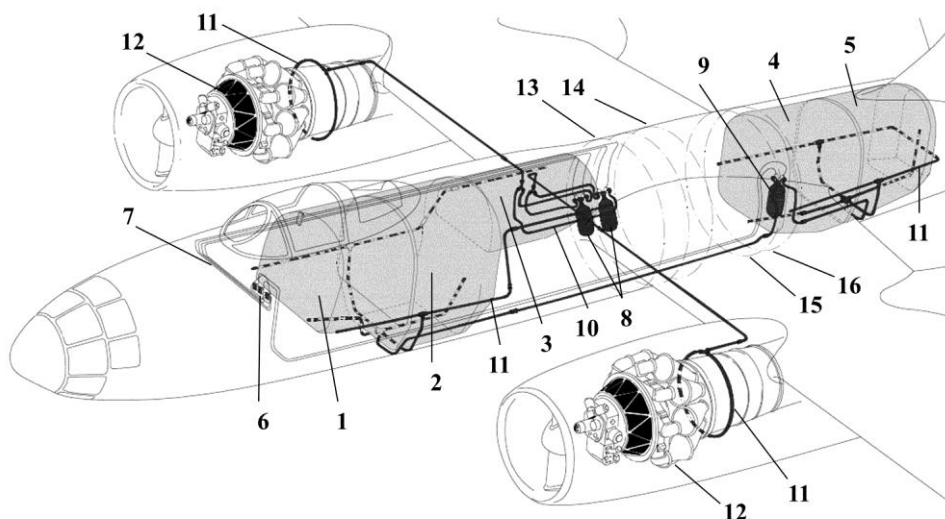
Fig. 2 Ilyushin Il-28 fire-fighting system [2]: (1) fuel tank no. 1, (2) fuel tank no. 2, (3) fuel tank no. 3, (4) fuel tank no. 4, (5) fuel tank no. 5, (6) fire protection system control panel in the cockpit, (7) electrical wiring between the control panel and fire extinguishant pressure bottle pyrocartridges, (8) extinguishant pressure bottles no. 1 and 2, (9) extinguishant pressure bottle no. 3, (10) extinguishant distribution tubing, (11) extinguishant spray manifolds, (12) VK-1 jet engine, (13) partition no. 23, (14) partition no. 25, (15) partition no. 28, (16) partition no. 29

The Ilyushin Il-28 was equipped with a fire-fighting system consisting of two main segments: the Klimov VK-1 engines protection segment and the fuel tanks protection segment (see . 2).

The engine protection segment consisted of two eight-liter (5.7 kg) fire extinguishant pressure bottles with carbon dioxide located on the right side of the fuselage between partitions no. 23–25, distribution tubing, circular spray manifolds around the engine units and total of ten bimetallic membranes (fire detectors) to evaluate the static reaction temperature range of 110–140 °C. Five bimetallic cells were placed on each engine unit. Each fire bottle was fitted with two metallic membrane pyrocartridges that facilitated distribution of fire-extinguishing agent from either fire bottle to either engine unit, if necessary. Detection of an engine fire was indicated by two red warning lights (one for each engine) on the left panel in the cockpit (see Fig. 3). The pilot then

The fuel tanks protection segment consisted of one eight-liter (5.7 kg) fire extinguishant pressure bottle with carbon dioxide located in the fuselage between partitions no. 28 and 29, distribution tubing, and spray manifolds placed between the outer wall of the tanks and inner wall of the fuselage. Four of five fuel tanks were protected in this manner. The smallest tank no. 3 in the middle had no protection because it was assumed it would have been empty by the time of combat. Spray manifolds connected to the fire bottle were also placed inside of all five fuel tanks to keep constant overpressure of carbon dioxide above the fuel surface. It was a system of fire and explosion prevention in case the fuel tanks would have got hit during combat. The fuel tanks had rubber covering and were designed as self-locking [2], [12].

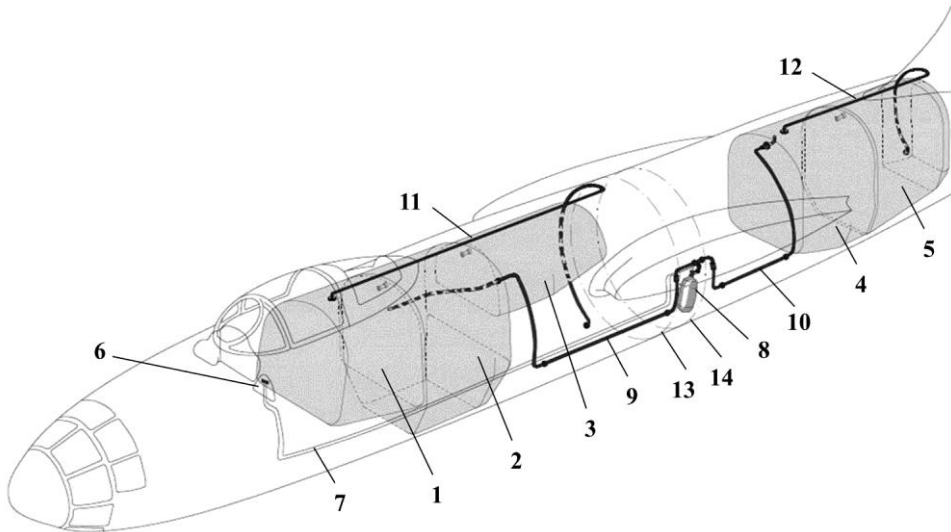
Fig. 4 Ilyushin Il-28 inert gas system [2]: (1) fuel tank no. 1, (2) fuel tank no. 2, (3) fuel tank no. 3, (4) fuel tank no. 4, (5) fuel tank no. 5, (6) inert gas system control panel in the cockpit, (7) electrical wiring between the control panel and pyrocartridge of the pressure bottle with CO₂ inert medium, (8) pressure bottle no. 4 with CO₂ inert medium, (9) supply tubing for forward fuel tanks, (10) supply tubing for aft fuel tanks, (11) discharge tubing for forward fuel tanks, (12) discharge tubing for aft fuel tanks, (13) partition no. 23, (14) partition no. 24

The system consisted of one eight-liter (5.7 kilograms) pressure bottle with carbon dioxide (CO₂) inert gas located in the left fuselage between partitions no. 23 and 24, two calibrated pressure reducing valves, distribution tubing, spray manifolds placed inside the fuel tanks no. 2 and 4 and discharge tubing (see Fig. 4).

In case of fire or a fuel leak, apart from the fire-fighting system, the pilot could activate the inert gas system using a switch located on the utility panel (above the fire-fighting system switches) on the left of the instrument panel in the cockpit.

The switch electrically activated the pyrocartridges on the pressure bottle with the inert carbon dioxide (CO₂) gas. The inert gas was delivered through the calibrated pressure reducing valves, distribution tubing and spray manifolds and distributed above the fuel surface in tanks no. 2 (forward) and 4 (aft). The reducing valves were continuously heated to prevent them from freezing. Adjacent fuel tanks no. 1 (forward) and 5 (aft) were supplied with CO₂ through connecting tubes. Only the smallest tank no. 3 in the middle had no protection because it was assumed it would be empty by the time of combat (see above). The excess pressure of CO₂ was drawn off by drainage pipes from tanks no. 1 and 4 outside the fuselage into the atmosphere. The overpressure above the fuel surface in tanks was constantly kept in the range of 0.1–0.15 kg/cm², i.e. approximately 9.8–14.7 kPa of the inert gas. The system functioned continuously until the gas in the pressure bottle was exhausted.

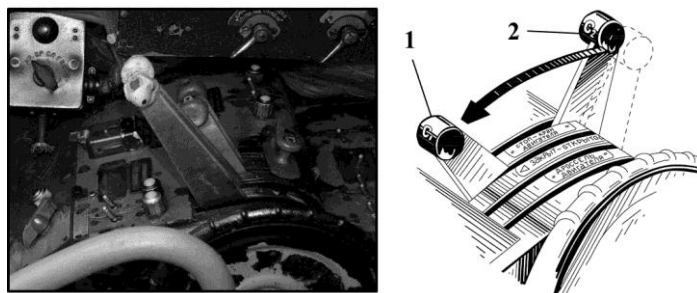
Fig. 5 Fuel shut-off cock levers on the Il-28 cockpit left hand side [7]: (1) C_1 fuel shut-off cock lever for the right engine, (2) C_2 fuel shut-off cock lever for the left engine

1. Switch off the fuel supply into the affected engine unit by pulling the fuel shut-off cock lever to the CLOSED position (see Fig. 5 below).
2. Turn off the fuel pump for the affected engine unit by setting the fuel system fire valve toggle switch to the CLOSED position. As a rule, the pilot waited a few seconds to see whether the engine unit fire was extinguished. If the fire persisted, steps III. and IV. followed (see below).
3. Reduce the flight speed to 300–350 km/h as quickly as possible.
4. Activate the fire extinguishing system by pressing the pyrocartridge activation push button for the pressure bottle corresponding to the affected engine unit. The pyrocartridge activation push button was placed under a cover labeled “engine fire extinction” on the main instrument panel left side below fire warning lights.
